**HISTORIC PRESERVATION REVIEW BOARD  
STAFF REPORT AND RECOMMENDATION**

Property Address:	<b>1208 3<sup>rd</sup> Street NW</b>	<input checked="" type="checkbox"/> Agenda
Landmark/District:	<b>Mount Vernon Square Historic District</b>	<input type="checkbox"/> Consent Calendar
ANC:	<b>6C</b>	<input type="checkbox"/> Denial Calendar
		<input checked="" type="checkbox"/> Concept Review
Meeting Date:	<b>September 24, 2009 (revised)</b>	<input checked="" type="checkbox"/> Alteration
H.P.A. Number:	<b>#09-314</b>	<input type="checkbox"/> New Construction
Staff Reviewer:	<b>Brendan Meyer</b>	<input type="checkbox"/> Demolition
		<input checked="" type="checkbox"/> Subdivision

The applicant, Third Street Church of God represented by Ted Daniels, presents a revised design and preservation plan based on actions taken by the Board at their July 23, 2009 meeting. The applicant seeks concept approval for a three-story side addition to a three-story apartment building at 1208 3<sup>rd</sup> Street NW and subdivision of lots. Plans were prepared by Pearson & Associates.

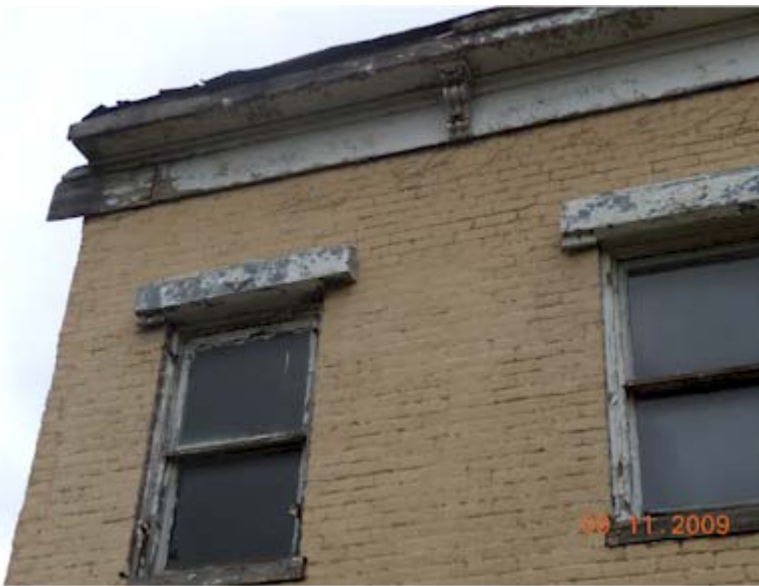
Figure 2 Windows and cornice, 1232 New Jersey Avenue

without evidence of recent spreading indicative of structural distress. Openings hold most their original windows, with some broken panes. Metal window hoods and wood cornices are intact in very good condition, only needing new paint and the smallest amount of patching to be restored, (Figures 2 and 3). Roof conditions can be assumed poor which would be the cause of the rot and moisture above and below the interior stairs of 1232.

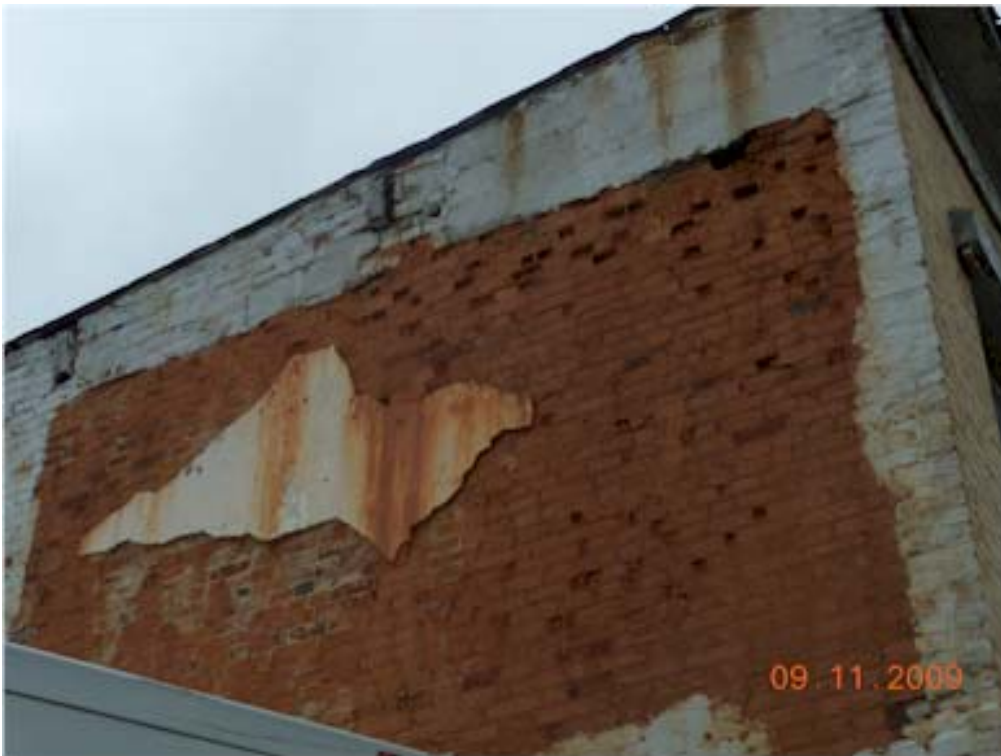
**Figure 4** Exposed party wall and deteriorating bricks

Conditions rapidly deteriorate towards the rear of the structures. The south wall of 1232 was originally an interior party wall, but it is now exposed. Its soft brick has been eroded by the weather and needs immediate attention to arrest deterioration, (Figure 4). Some bricks need to be replaced immediately and the entire surface coated sufficiently to protect the bricks from moisture. The rear of the structures are in the worst state. Large trees (juvenile and mature) have taken root in the masonry, (Figure 5).<sup>2</sup> Their root structure is progressively growing through the structure, dislocating face brick, windows, and other features.

- 1. The brick of the front and north side of the addition shall reasonably match the color, texture and dimension of the brick of the sanctuary and apartment building, and*
- 2. A condition report for 1232-1236 New Jersey Avenue NW, suitable for evaluation, from a structural engineer with professional experience evaluating 19<sup>th</sup> century masonry structures, be delivered to HPO prior to final approval of the addition.*
